RI 9280

## Leakage Across a Bituminous Coal Mine Barrier

By Noel N. Moebs and Gary P. Sames

BUREAU OF MINES

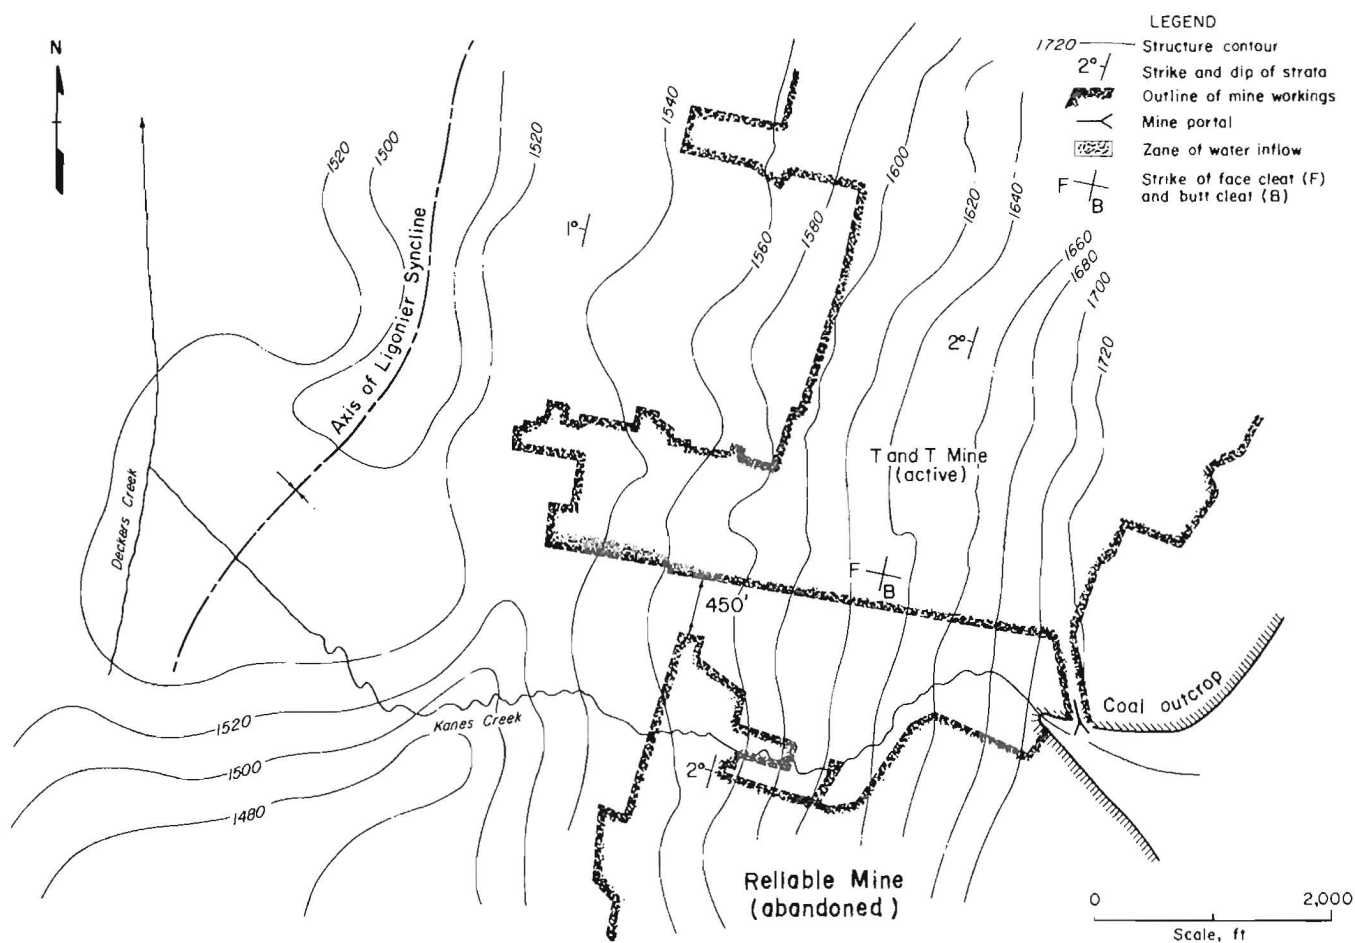
Figure 4.—Structure contours on Upper Freeport coalbed.

The coalbed is 48 to 54 in thick and dips about 2° westward towards the axis of the Ligonier Syncline (fig. 4). The principal coal cleat trends are N 10° E (butt) and N 79° W (face). Immediately beneath the coalbed is 2 ft of dark gray clay shale. The immediate mine roof normally consists of 2 to 15 ft of hard shale and shale with sandstone streaks. This is overlain by 50 to 60 ft of generally massive, coarse-grained Mahoning Sandstone. Roof rolls,

Because of the wide spacing of surface drill hole data points neither isopach (fig. 10) nor structure contour (fig. 4) maps suggested any local conditions that might account for the water. The existence of a surface diamond drill hole that passed within 100 ft of the major leakage was of little help in explaining the anomalous conditions because the driller's log was generalized and showed only a normal stratigraphic sequence and a very thick section of undifferentiated sandstone.

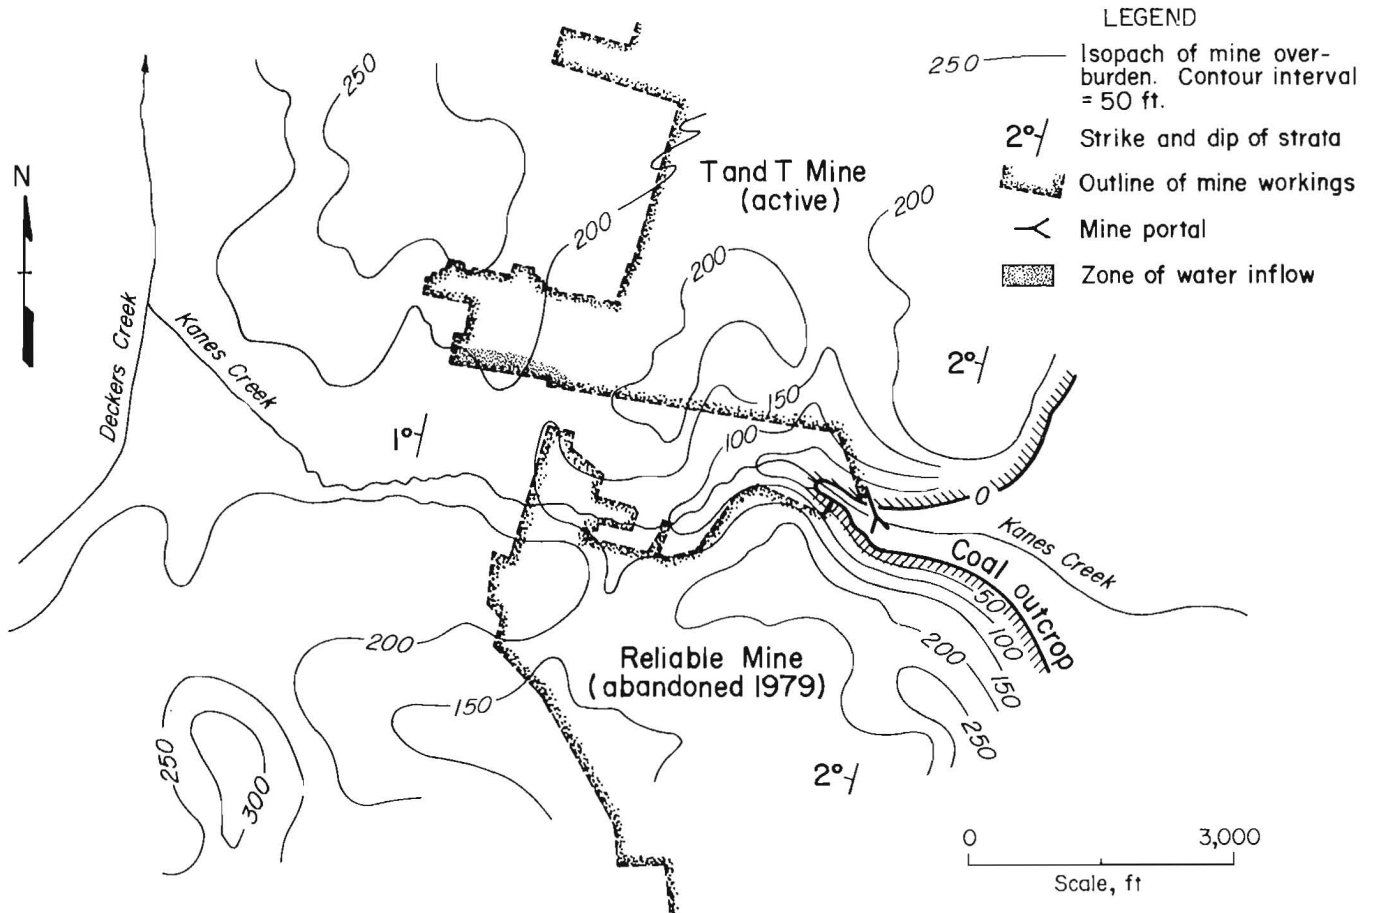
Figure 5.—Isopach of mine overburden.

or sandstone-filled paleochannels, sometime extend a short distance into the top of the coalbed. This quartzose sandstone is extremely hard and presents a severe problem when attempting to drill roof bolt holes. Slickensides in the roof are common but generally not troublesome when supporting roof. No well-developed system of jointing or faults has been detected in this mine. Overburden ranges from 0 ft at the portal to 225 ft near the western limits (fig. 5).

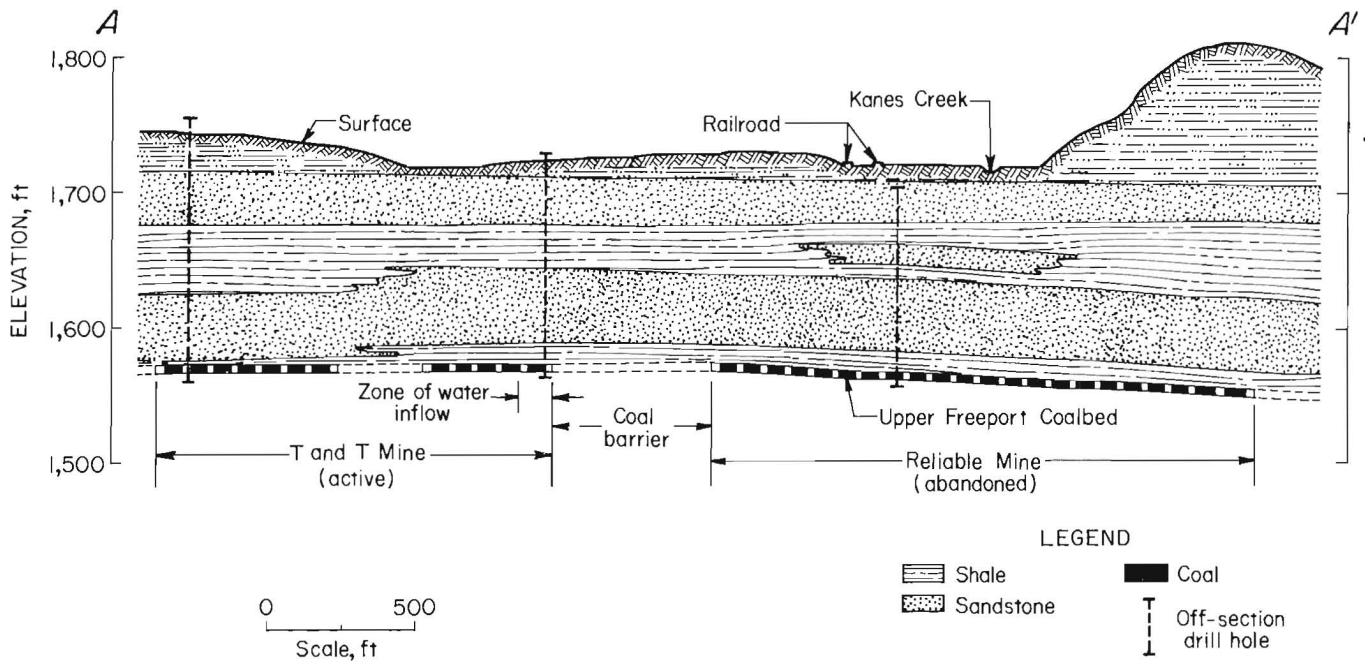
Figure 6.—Transverse profile of mine area.

The mine was opened in 1982 and developed westward, downdip, and adjacent to a flooded mine. Transverse (fig. 6) and longitudinal (fig. 7) profiles illustrate these relations. Large coal reserves lie west and downdip of the adjacent mine and access to these reserves, other than by shaft or closely skirting the adjacent mine, is limited.
